WT- 728

NEVADA PROVING GROUNDS

March - June 1953

FIELD FORTIFICATIONS

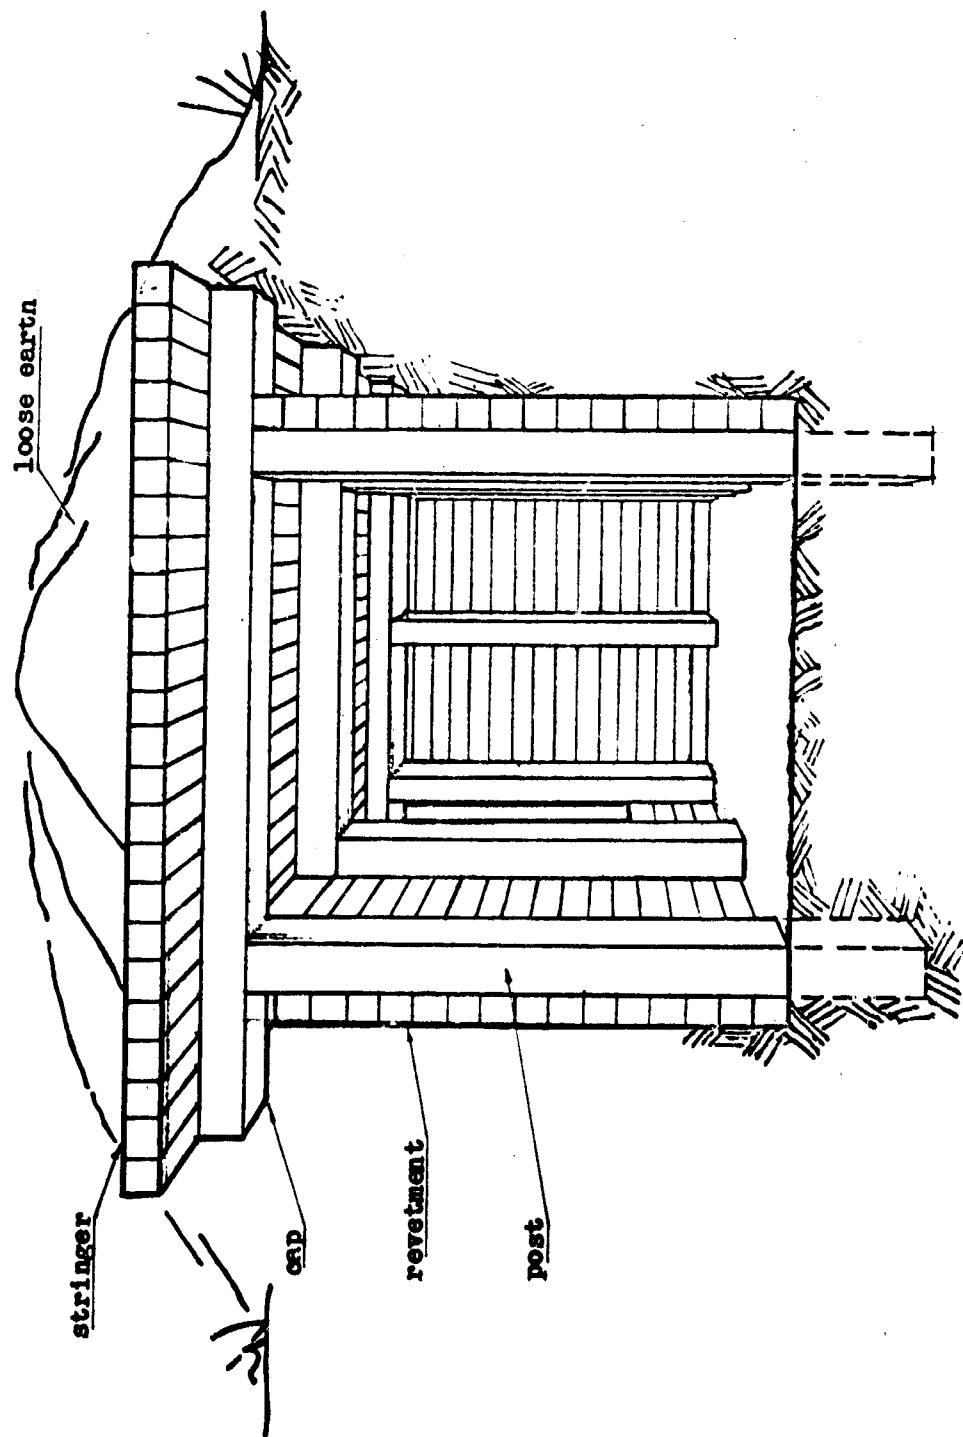
Fig. 2.1 Command Post with Continuous Stringers

The construction of the command posts is shown in Figs. 2.1 and 2.2. The figures show an underground side view, with the near wall and post removed. The command posts were constructed with their stringers at grade level. The overall inside dimensions were 6 ft x 6 ft x 6 ft. The overall dimensions of the cover were 9 ft x 9 ft overlain with about 2 ft of loose earth. The entrance excavation protruded 6 ft from the wall of the structure and was 2 ft wide, with three 2 ft steps cut down to the command post proper. The sizes and spans of the timbers and the various materials used for each component in each command post are included in Table 3.1.

As shown in Table 3.1, most of the damage was confined to the failure of the center 4" x 4" caps and stringers at midspan. The evaluation of the damage to top fillers in the table does not take into consideration that small portion covering 4 ft of the entranceway. In general, the entrances were about half filled with loose earth; and the top filler immediately over the entrance was crushed inward enough to make access to the fortification difficult. It appeared that some of the loose earth mound covering the fortifications was removed by the blast. In most cases, the volume of the mounds was reduced by about one-fifth.

The peak overpressure in Area 3.9-A was approximately 300 psi, extrapolated value. All of the command posts were severely damaged. About one-fourth of the 8" x 8" posts failed in compression; most of the posts were displaced, and some appeared to have been driven slightly into the ground. The center 8" x 8" caps were broken and the two end caps severely shattered, showing 1 in. deep impressions where they had rested on the posts. About one-half of the 4" x 4" stringers were broken, the remainder suffering no apparent damage other than being removed from position. It appeared that the covers had been partly blown down into the fortifications and partly scattered about the area. Even though there were many undamaged timbers, all of the cover timbers were separated, no cover remaining even partly intact. The fortification excavations were about half filled with loose earth and rubble. The 4" x 4" timber revetments were bowed in, but the timbers retained their same relative positions and were not damaged. One command post of relatively light construction, 4" x 4" timbers and corrugated iron, was completely destroyed.

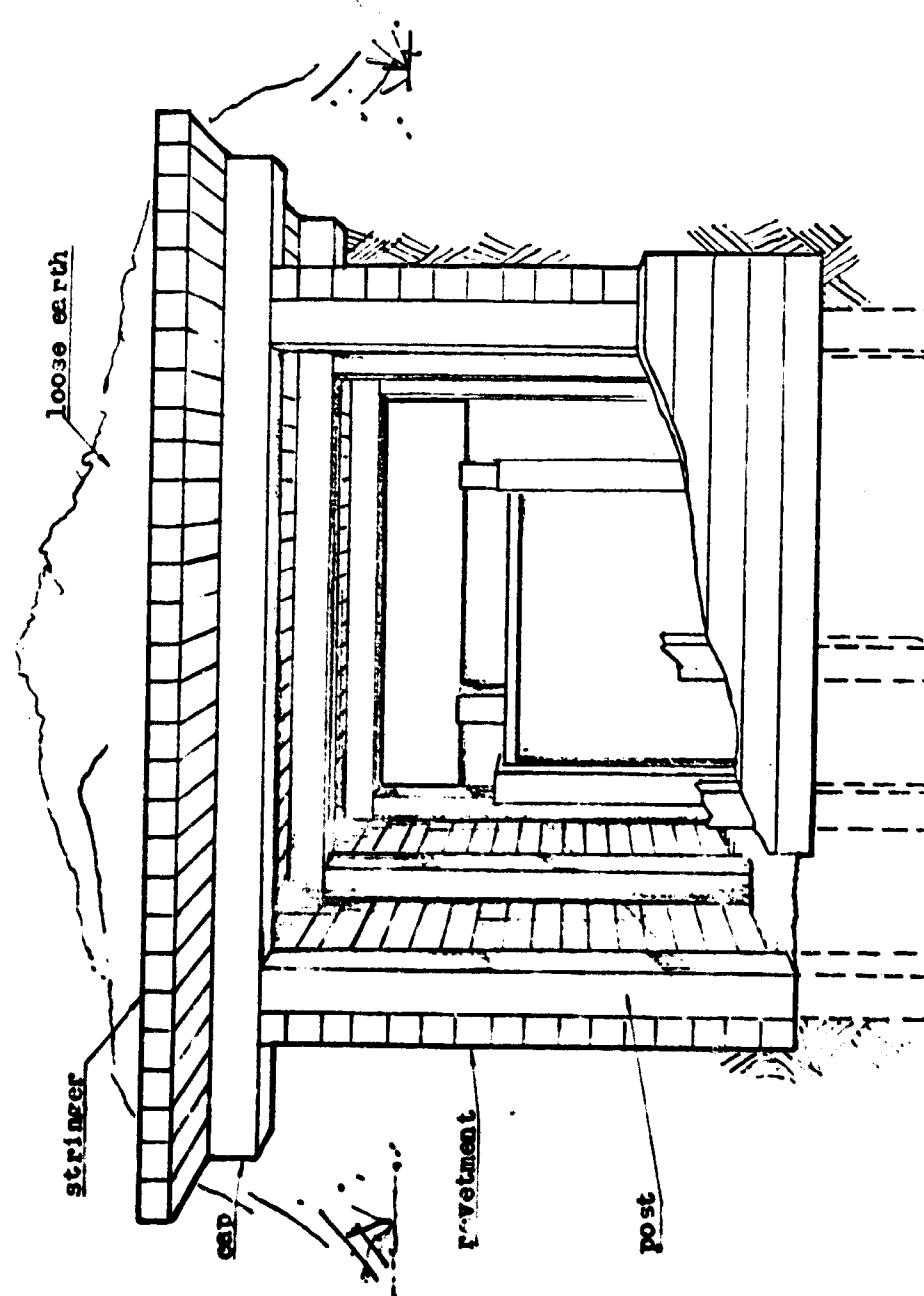
Fig. 2.3 Machine Gun Emplacement with Continuous Stringers

The construction of the machine gun emplacements is shown in Figs. 2.3 and 2.4. The figures show a partially underground rear view, with a portion of the rear wall and posts cut away. The stringers were 1 $\frac{1}{2}$ ft above grade level, and the overall dimensions of the cover were 8 $\frac{1}{2}$ ft x 10 ft overlain with about 1 ft of loose earth and sandbags. The overall inside dimensions were 5 $\frac{1}{2}$ ft long x 7 ft wide x 6 ft tall. The entrance excavation protruded 6 ft from the rear wall and was 2 ft wide and 2 ft deep, leaving a 2 ft step down to the floor of the emplacement. The sizes and spans of the timbers and the various materials used for each component in each machine gun emplacement are included in Table 3.2.

As shown in Table 3.2, most of the damage to structural members was confined to the failure at midspan of the two front 4" x 4" caps. The evaluation of the damage to revetments and top fillers is problematic, because the damage seemed to be as attributable to poor construction as to lack of strength in the materials. In Area 3.9-A where the

The three emplacements having 4" x 4" timber structural frames were destroyed beyond recognition. The four emplacements utilizing 8" x 8" timbers for posts and caps and 4" x 4" timbers for stringers and revetment were destroyed but still recognizable. Confining the discussion to the latter four emplacements, a few useful observations can be made. The superstructures were entirely removed, leaving the excavations almost filled with scrambled timbers, loose earth, and rubble. A few of the 8" x 8" posts remained undamaged; and, where the posts had remained, the 4" x 4" timber revetments were relatively undamaged and in position. The walls of the emplacements were pushed inward, reducing the dimensions somewhat below the original dimensions. There were a multitude of undamaged 4" x 4" timbers strewn in and about the emplacements, some of which must have been stringers and others part of the revetments. It appeared that if the posts had held, the 4" x 4" timber revetments would have held also. In general, damage to the machine gun emplacements was more severe than the damage to command posts of the same timber size construction.

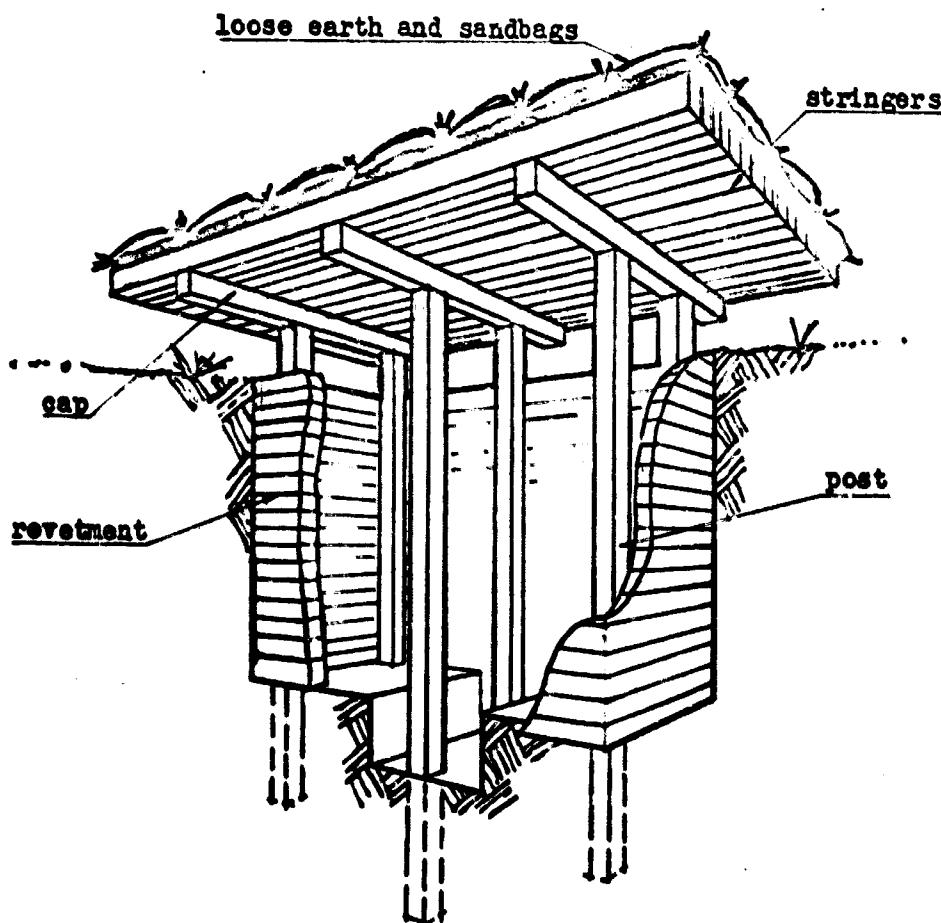
Fig. 2.5 Two-man Foxhole with Continuous Stringers

The construction of the two-man foxholes is shown in Figs. 2.5 and 2.6. The figures show an underground corner view, with portions of the walls cut away. The overall inside dimensions of the foxholes were 2 ft long x 6 ft wide x 5 $\frac{1}{2}$ ft tall. The stringers were 1 ft above grade level, and the cover had overall dimensions of 5 ft x 9 ft overlain with about $\frac{1}{2}$ ft of loose earth and sandbags. On some of the foxholes, not shown, the cover had no overhang reducing the dimensions to 2 ft x 6 ft. The timber sizes and spans and the materials used in each foxhole are included in Table 3.3.

As shown in Table 3.3, there was no appreciable damage to the individual structural members of the foxholes. In Areas 3.9-A and 3.9-B, there was little damage to top fillers and most of the loose earth and sandbags covering the foxholes remained in place. In these areas, a few of the 2" x 4" posts were driven farther into the ground, allowing the covers to slant. In Area 3.9-C, the foxholes having the more substantial revetments and top filler, 1" x 6" lumber, suffered no damage other than the removal of loose earth and sandbags. Foxholes with lighter revetments and top filler, chicken wire and burlap or pasteboard, suffered considerable derangement of their superstructure. In some cases, the timbers forming the cover were pulled apart at their joints; and, in other cases, the whole cover frame was displaced, pulling the posts out of position. The top filler materials, sandbags, and loose earth were

The only thing that remained of the foxholes was the 4" x 4" revetment timbers and a few 4" x 4" posts. Most of the foxholes were completely filled in, but two were still open enough to indicate the process of failure. It appeared that the two 6 ft walls had been moved inward uniformly, reducing the original 2 ft dimension of the foxholes to about 8 in. in these two cases and completely closing the foxholes in all other cases. Other than this, the revetment timbers of the two partially open foxholes were relatively undamaged and retained their same relative position.

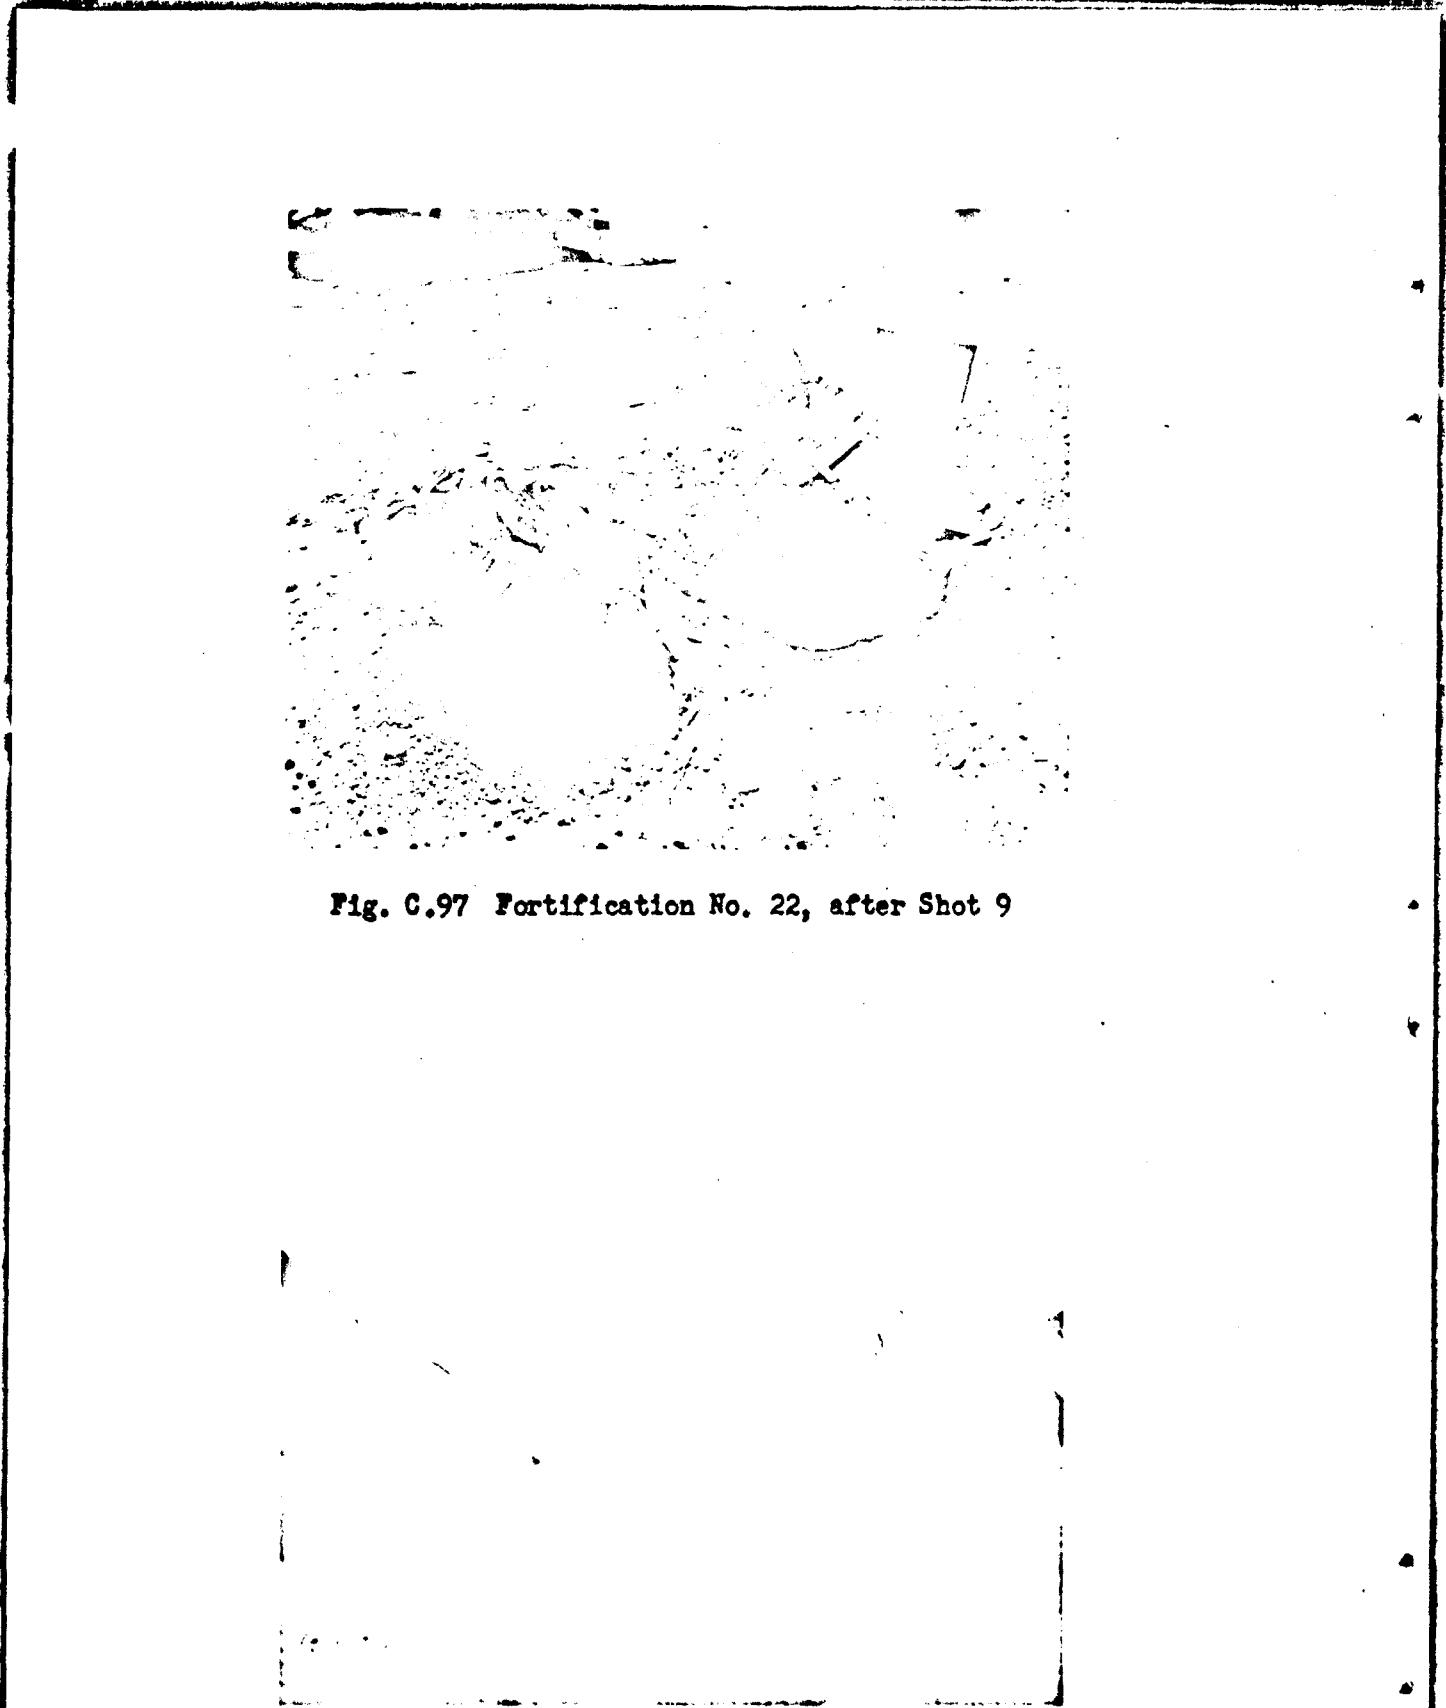
Fig. C.97 Fortification No. 22, after Shot 9

Fig. C.98 Fortification No. 22, after Shot 9

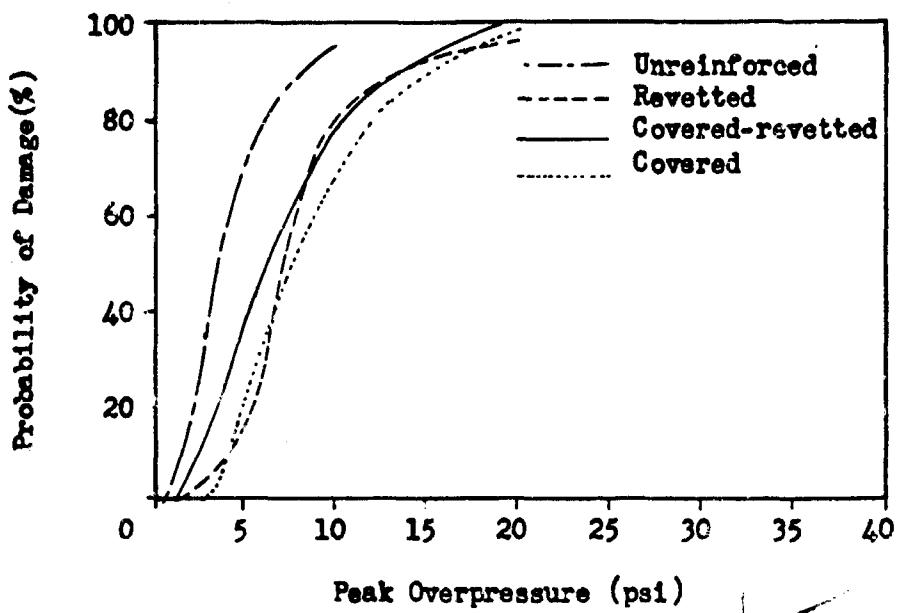
Fig. G.1 Probability of Blast Damage to Field Fortifications vs Peak Overpressure Scaled to 1 KT Based on Desert Rock Data From the Underground, Surface, and Air Bursts.

As can be seen in Figs. G.1 to G.4, the Desert Rock data show very little difference between the damage susceptibility of the three types of reinforced fortifications. Therefore, the Desert Rock data, which was presented to include four types of fortifications, should be considered to include only two, unreinforced and reinforced.

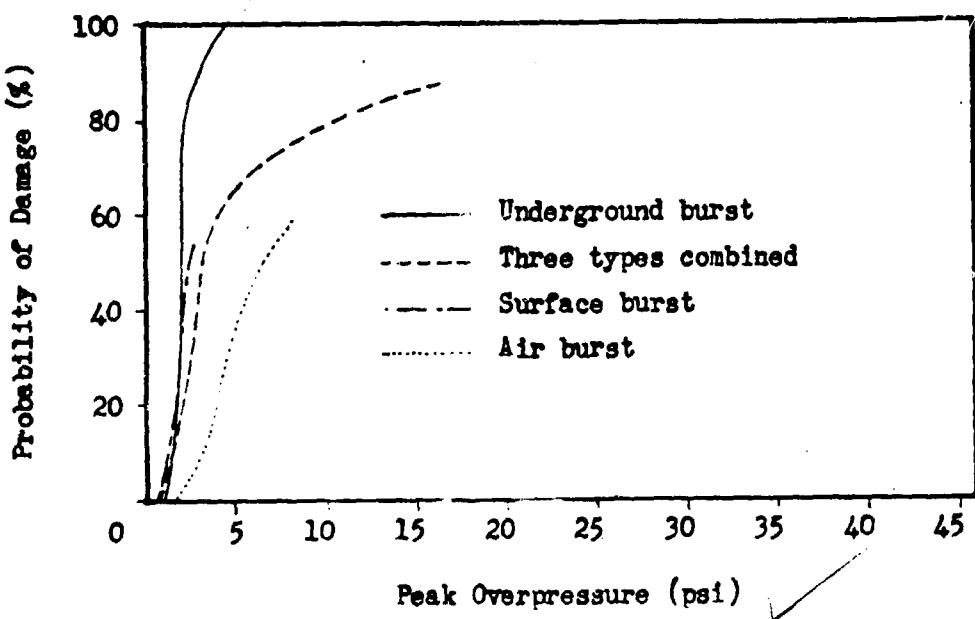
Fig. G.3 Probability of Blast Damage to Unreinforced Field Fortifications vs Peak Overpressure Scaled to 1 KT for the Desert Rock Underground, Surface, and Air Bursts.

The damage curves presented with peak overpressure as abscissa, Fig. G.3, and G.5, are rather steep and lend themselves to the setting up of damage categories, which are shown in Table G.4 below.
